## COMMERCIAL WINDSTORM MITIGATION REPORT

Marilyn Pines Unit II Condominium

## COMMERCIAL WINDSTORM MITIGATION REPORT (OIR-B1-1802)

2060 Marilyn St, Bldg C, Units 119-120

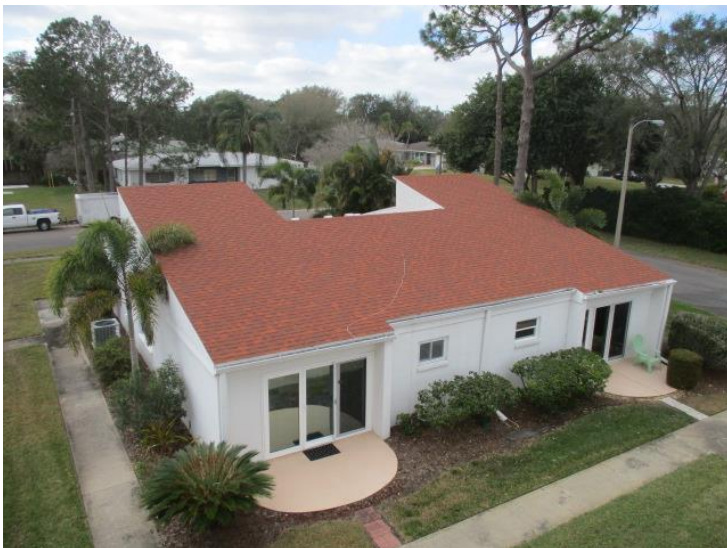
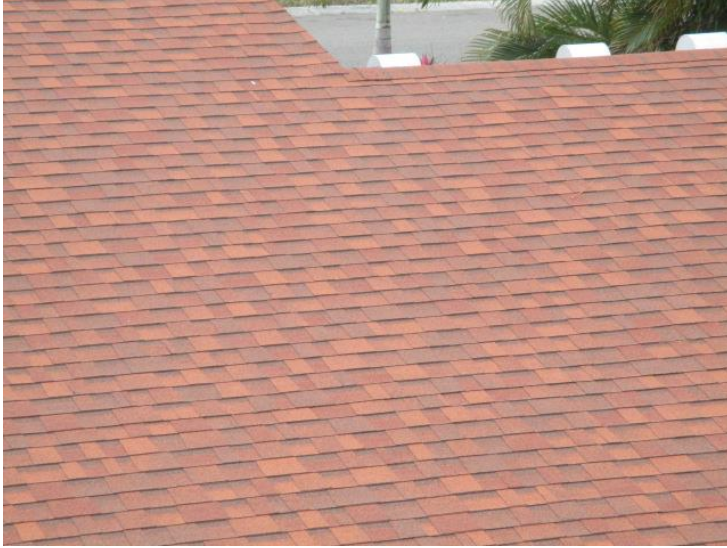
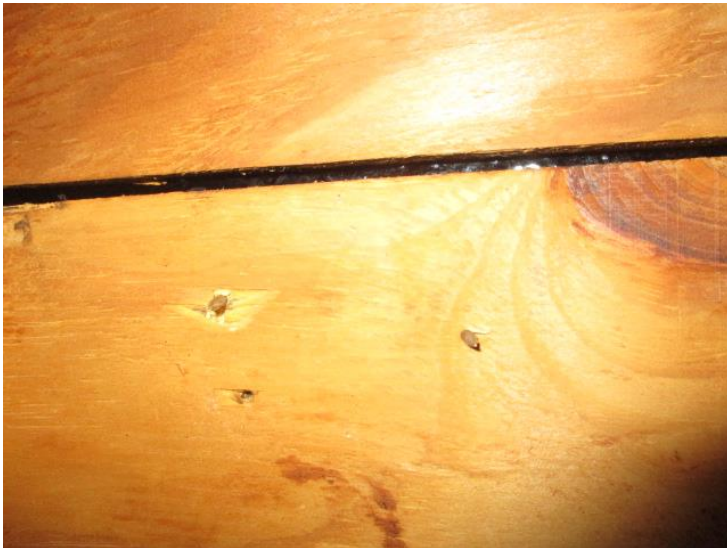
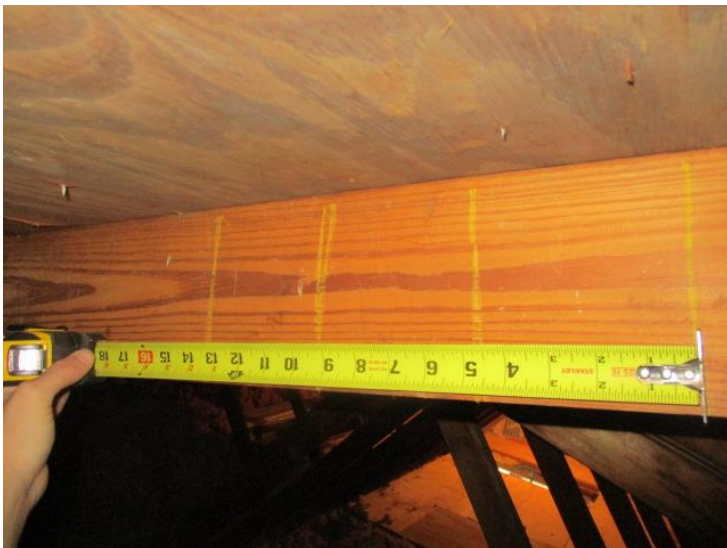
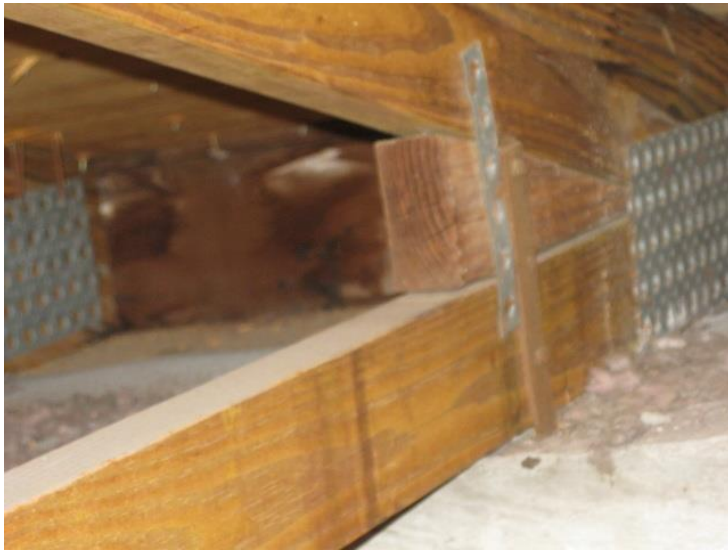
3. **Roof Deck Attachment:**        **Level C**  
Comments:                                      Inspection verified 1/2" plywood roof deck attached with 8d nails at a minimum 6" on the edge & 6" in the field.

4. **Roof to Wall Attachment:**        **Toe Nails**  
Comments:                                      Inspection verified embedded straps fastened with less than three nails.

5. **Roof Geometry:**                      **Other Roof**  
Comments:                                      Inspection verified a gable roof shape.
6. **SWR:**                                      **Yes**  
Comments:                                      SWR was verified at time of inspection. The Secondary Water Resistance verified is a self-adhering peel and stick.

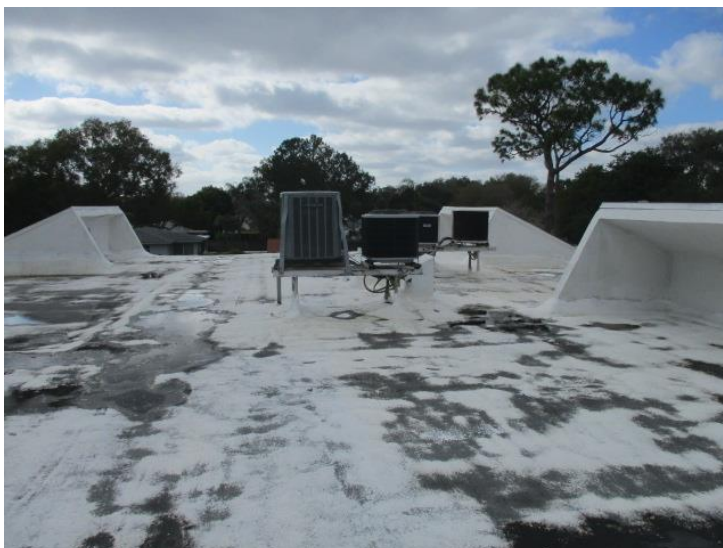
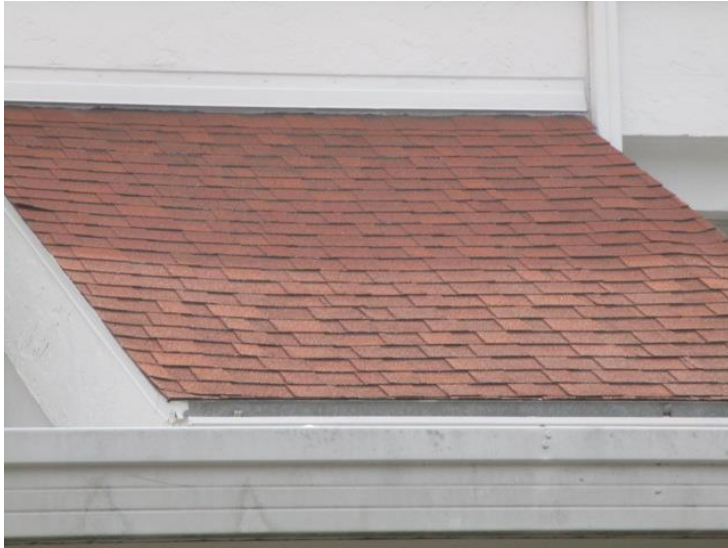
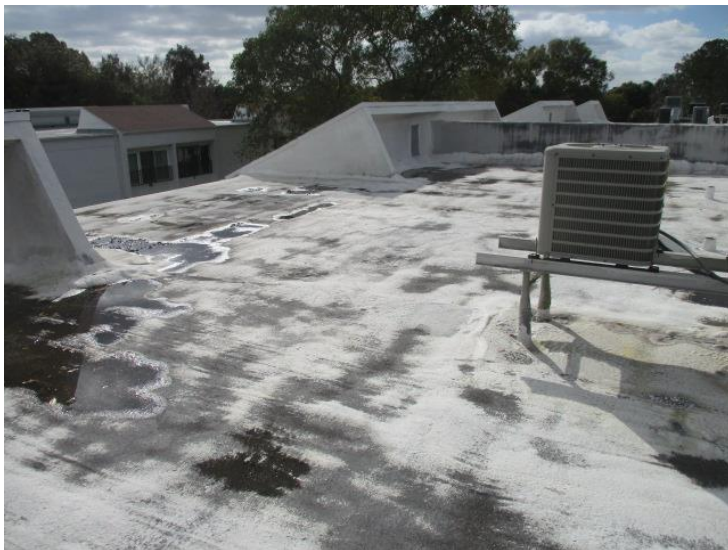
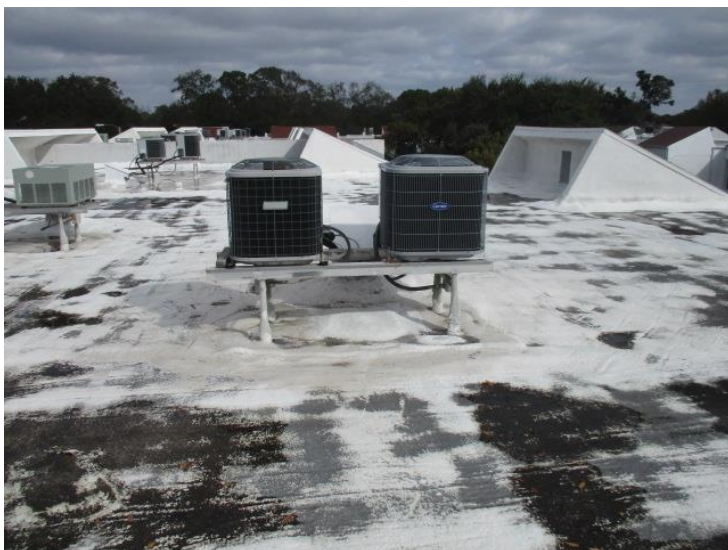
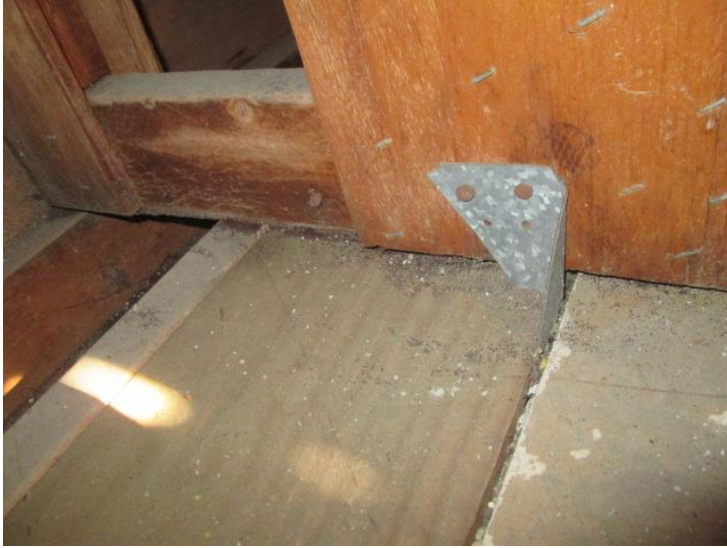
- 2. Roof Covering:**                      **FBC Equivalent**  
Comments:                                      The pitched roof covering was replaced in 2003. The roof permit was confirmed and the permit number is BCP2003-05345. Flat roofs polyurethane foam coating was applied in 2020. The permit was confirmed and the permit number is BCP2020-010175. This roof was verified as meeting the building code requirements outlined on the mitigation affidavit.

- 6. SWR:**                                      **No**  
Comments:                                      No SWR verified.
- 7. Opening Protection:**                **None or Some Glazed Openings**  
Comments:                                      Inspection verified some metal shutter opening protection. Not all glazed openings were protected with impact resistant coverings.

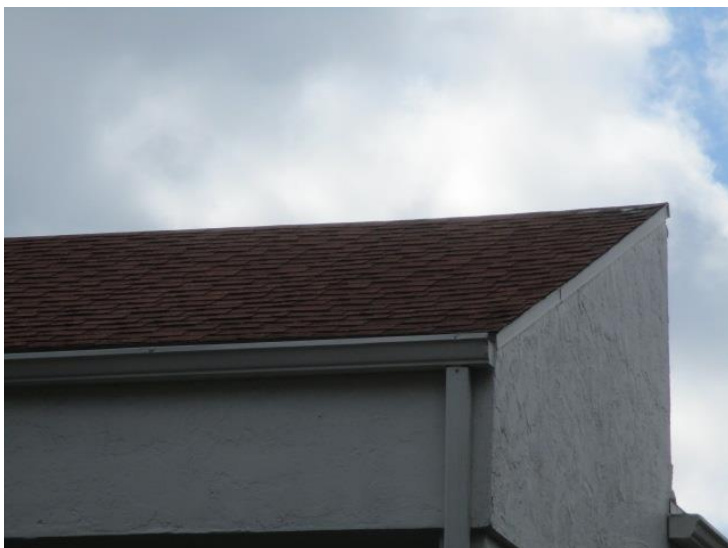
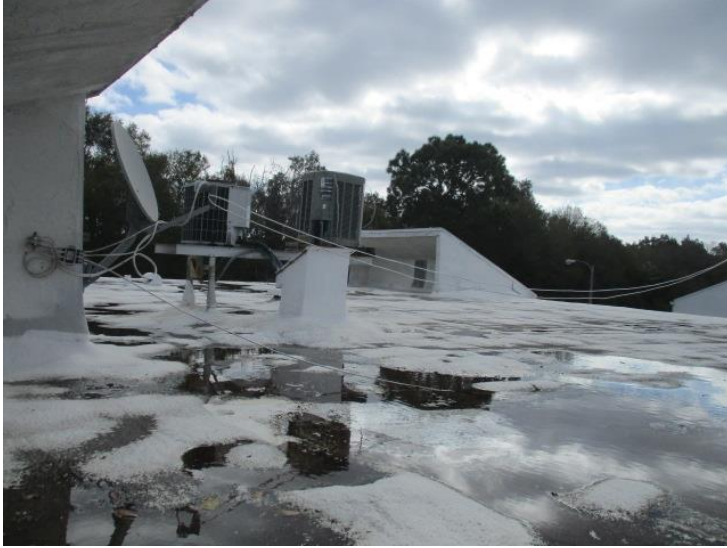
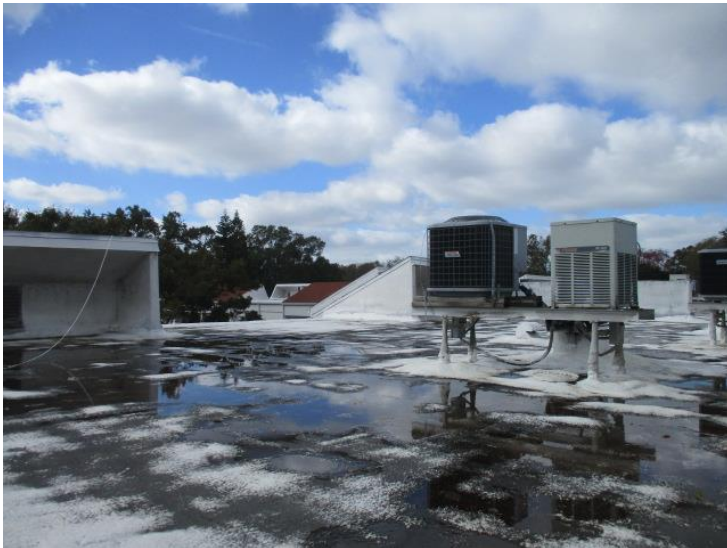
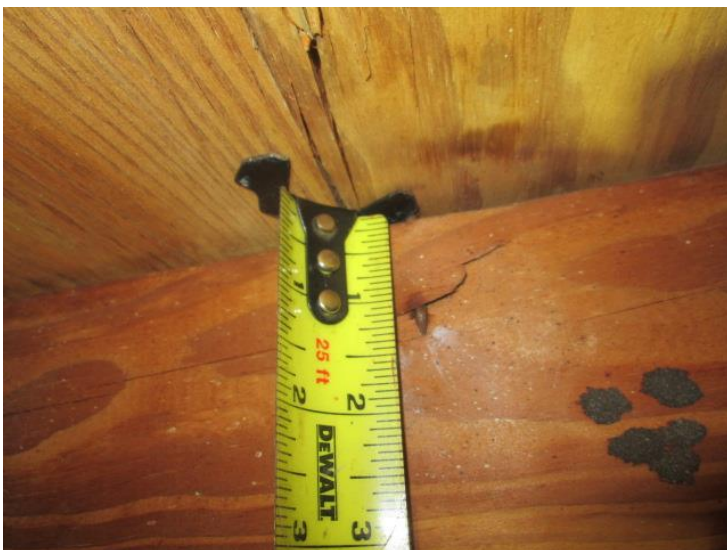
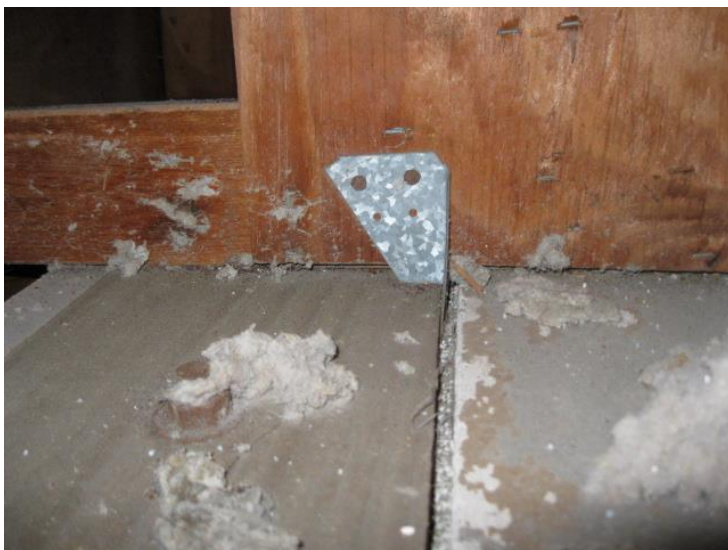
- 2. Roof Covering:**                      **FBC Equivalent**  
Comments:                                      The pitched roof covering was replaced in 2003. The roof permit was confirmed and the permit number is BCP2003-05345. Flat roofs polyurethane foam coating was applied in 2020. The permit was confirmed and the permit number is BCP2020-010175. This roof was verified as meeting the building code requirements outlined on the mitigation affidavit.

- 5. Roof Geometry:**                      **Other Roof**  
Comments:                                      The roof shape is made up of a combination of flat and pitched sections. The flat area of the roof comprises approximately 75% of the total roof area.

- 6. SWR:**                                      **No**  
Comments:                                      No SWR verified.
- 7. Opening Protection:**                **None or Some Glazed Openings**  
Comments:                                      Inspection verified some metal shutter opening protection. Not all glazed openings were protected with impact resistant coverings.
